**BUILDING
ENVELOPE
SOLUTIONS Inc.**

BES participates in the restoration of the Solomon R. Guggenheim Museum

Structural renovations of the building included insulating thermal short circuits that were causing moisture problems in the gallery spaces.

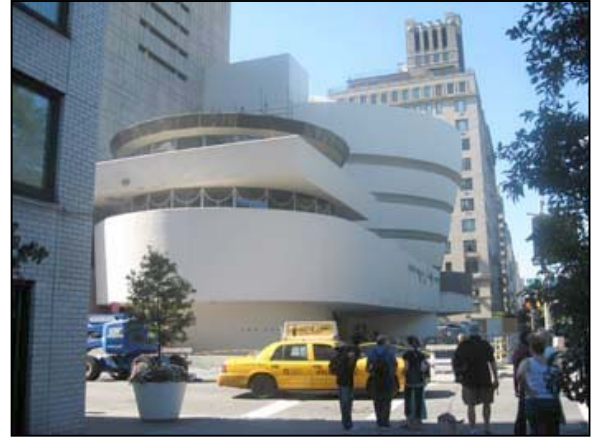
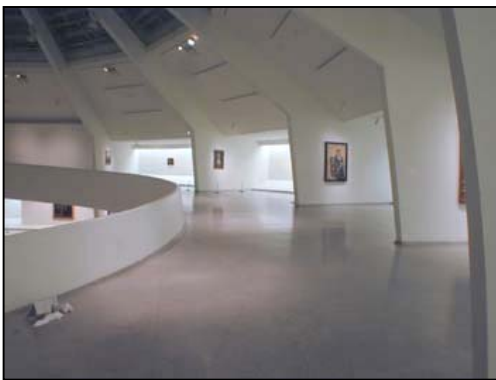
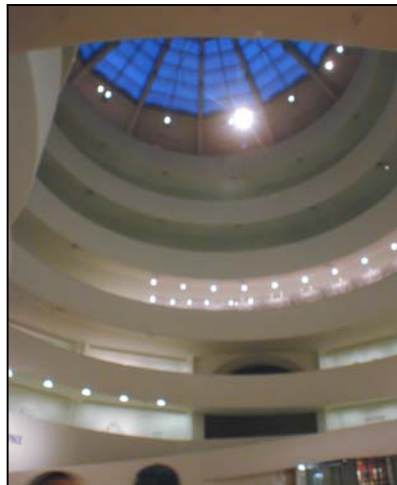
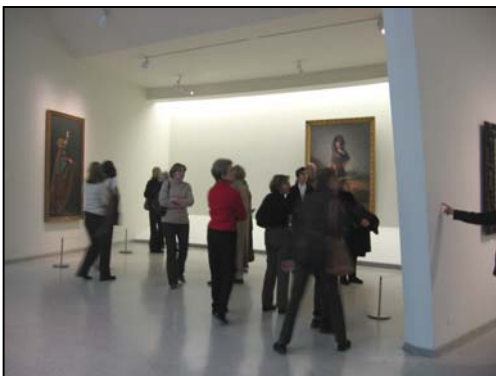
The problem that was to be addressed was a gap in the insulation at the intersection of the exterior wall and the sloped floor that occurred around the perimeter of the ramped gallery space. Relatively high humidity levels in the conditioned indoor space caused condensation on the interior surfaces at these locations.

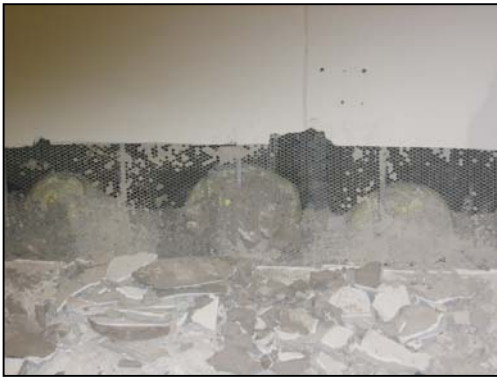
The original plan was to demolish the lower portion of the walls in the areas where the insulation was missing, install insulation, and repair the interior finishes. This plan included an extended period where closing the main section of the museum would be required. The photo to the left shows a small test area where the plaster was removed, as in the original plan, to confirm the effectiveness of the approach.

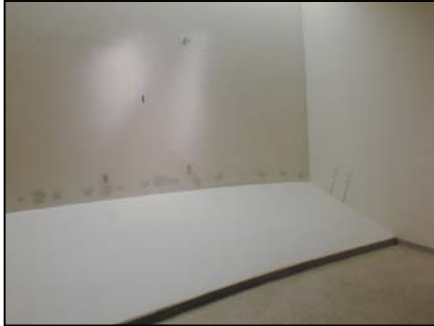
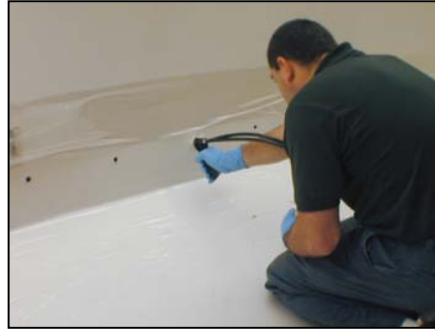
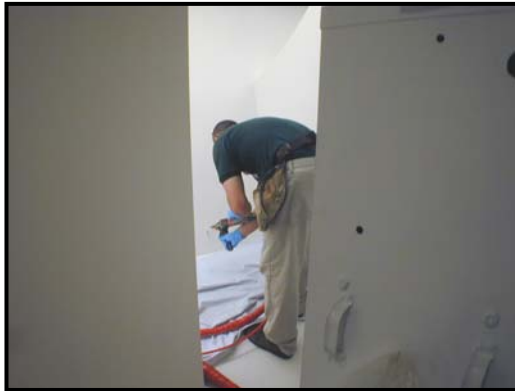
BES developed an approach that avoided the need for demolition and replaced the open spray application of closed-cell foam insulation with an injection process which filled the voids in the existing insulation with closed-cell polyurethane foam through small holes in the interior plaster finish.

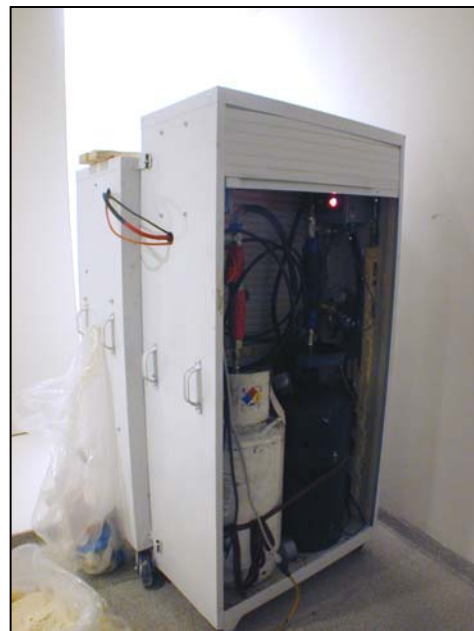
Specialized portable injection equipment was developed for this remote application.

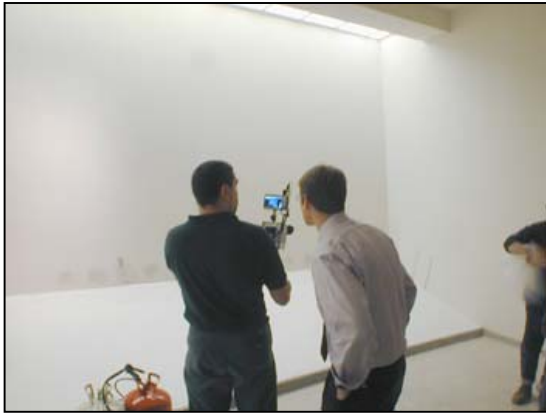
This process was monitored by infrared thermography done while the exothermic heat of the chemical reaction was present. This verified that the void was filled to the required level with the new insulation. This quality assurance procedure was video recorded as the work progressed.

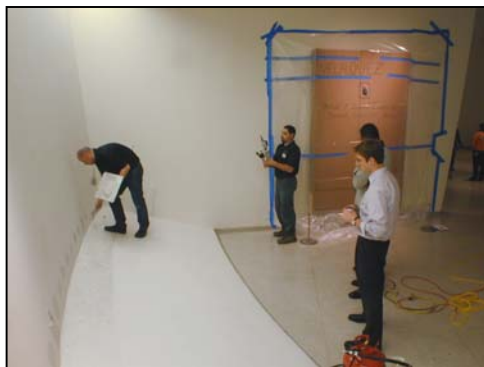
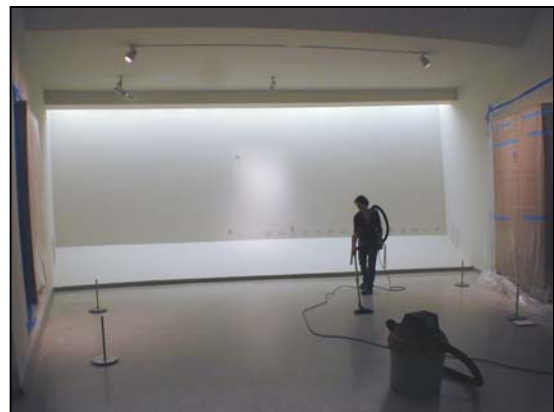
The work was organized in sections. Each night after normal museum operating hours, holes were drilled, the cavity injected with foam, and the holes patched and painted. Work progressed in this way until all the sections were completed. Closing the museum to the public was never required.
